RESERVE BUDGET ANALYSIS

SHAKER LANDING CONDOMINIUM
ENFIELD, NEW HAMPSHIRE

DATE: October, 2014

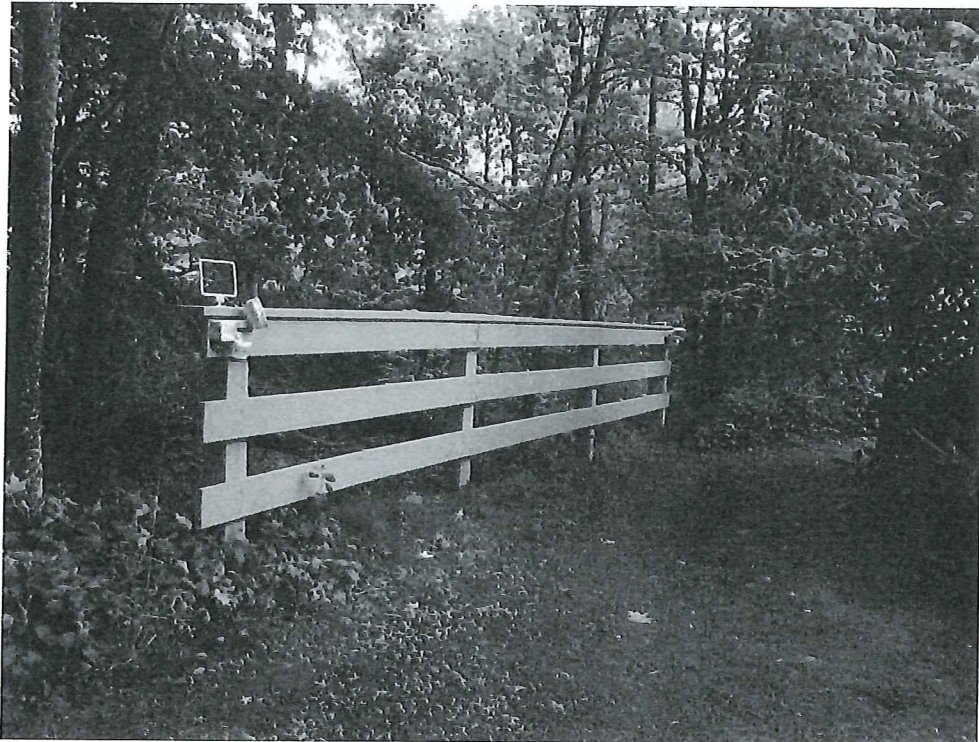
Photograph #1 - Fence At North End Of Development

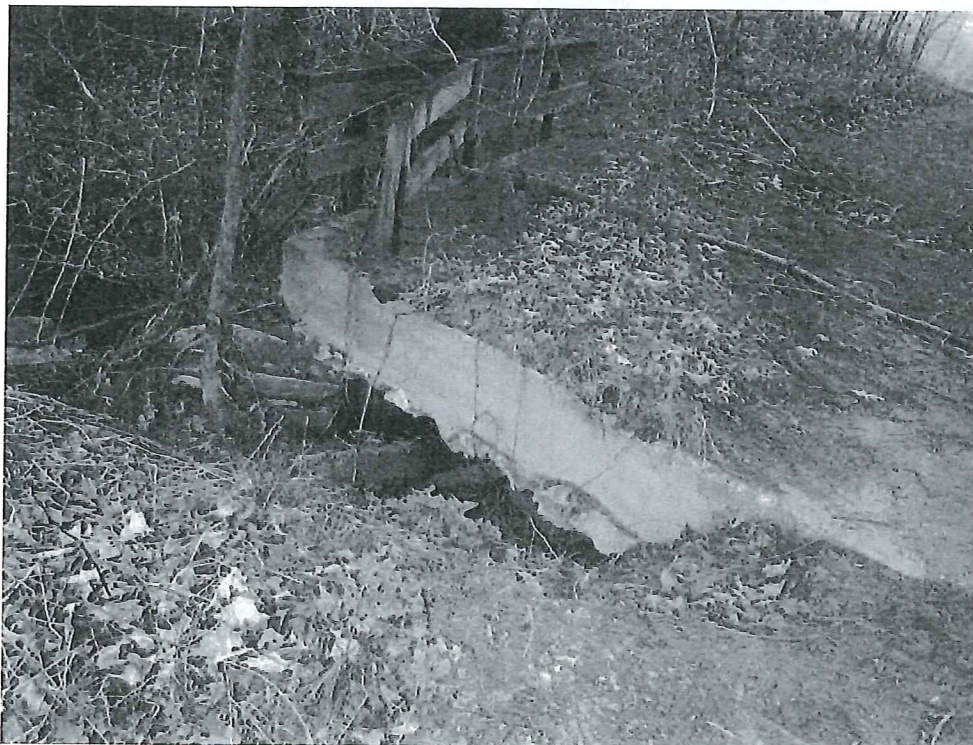
Bridge - There is a deteriorated concrete bridge structure over the stream on the north end of the property (see Photograph #2). The fill materials around the structure have eroded leaving a number of potentially unstable areas which could create safety issues for people walking over or around the bridge. We would recommend that the bridge be removed or these areas be otherwise stabilized. It is our understanding that the bridge is not the property of the Condominium Association.

Photograph #2 - Bridge At North End Of Development

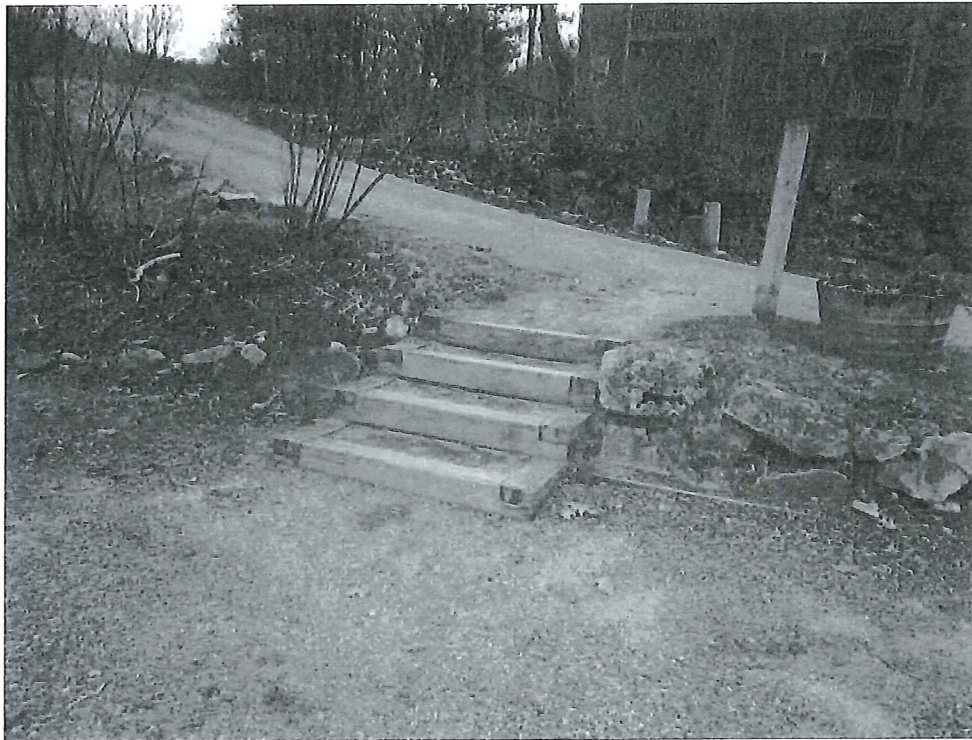
Photograph #3 - In-Fill Stairway

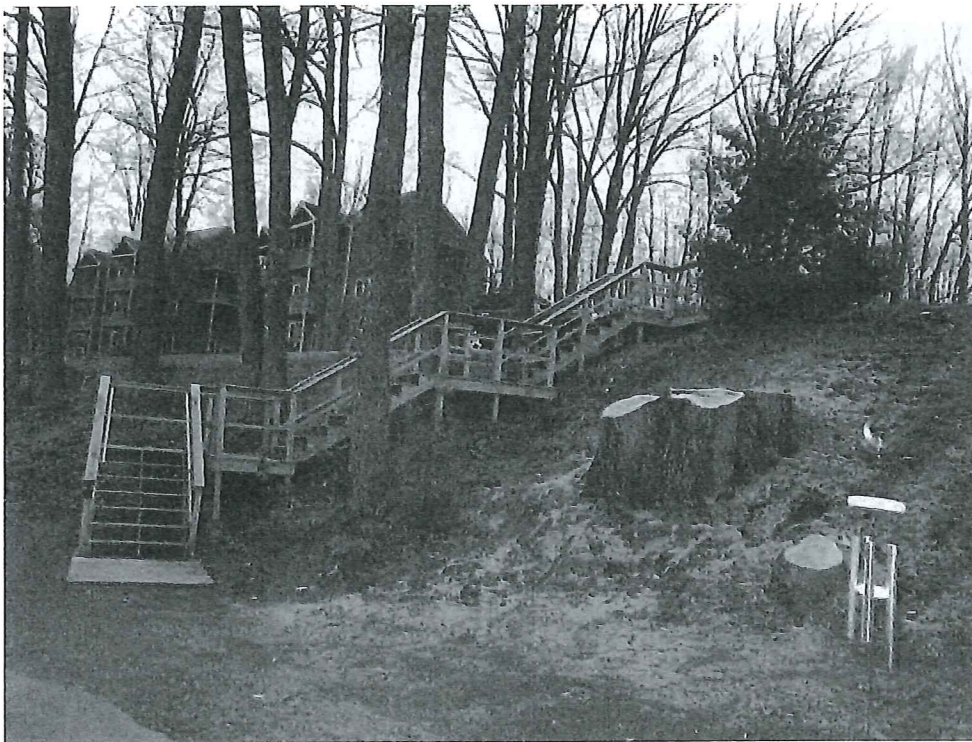
Photograph #4 - Framed Stairway

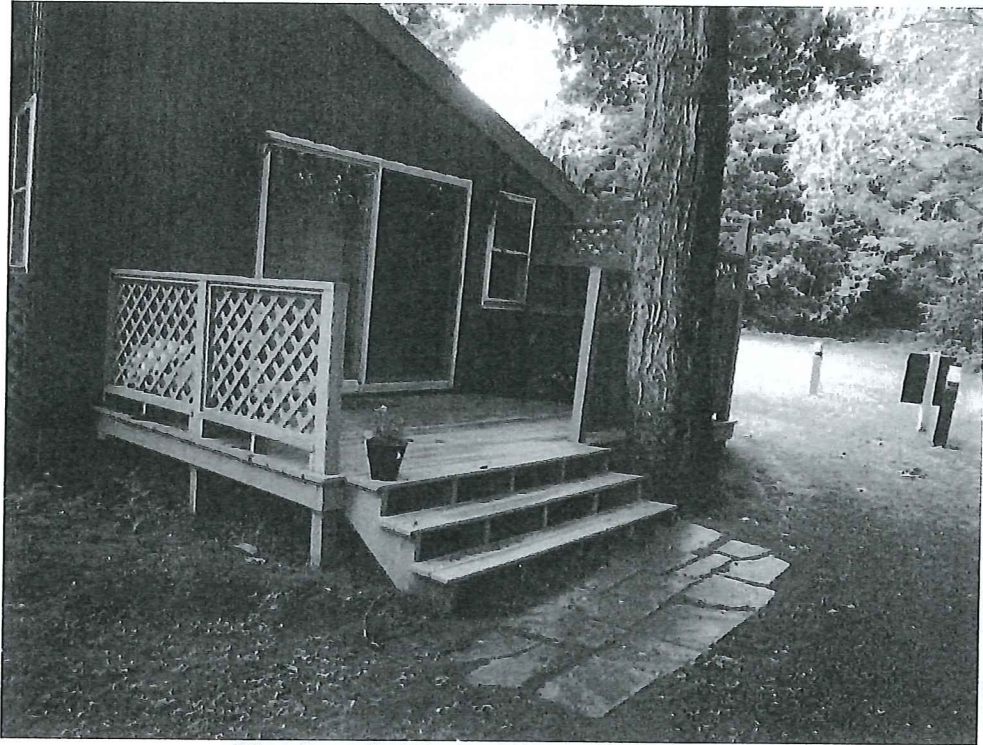
Photograph #5 - Triplex Exterior Deck

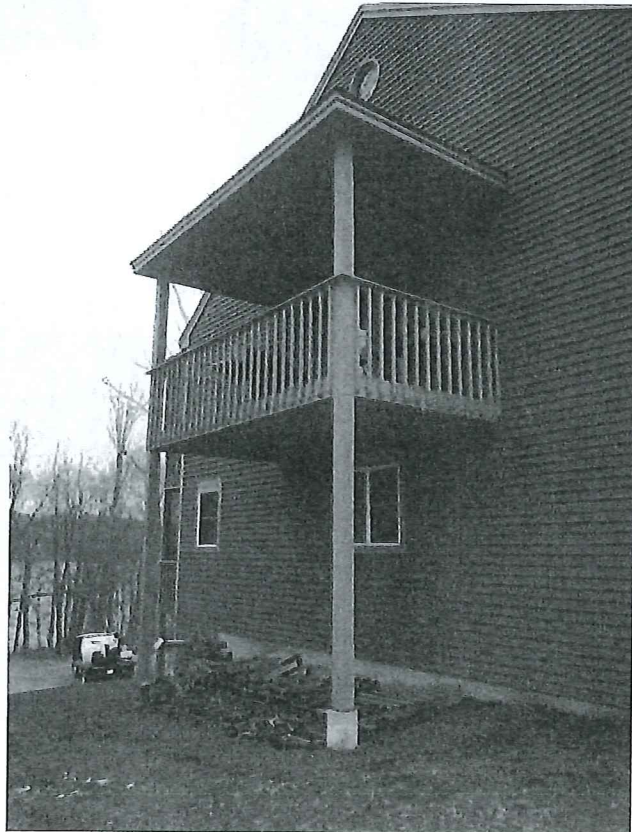
Photograph #6 - Duplex Exterior Deck

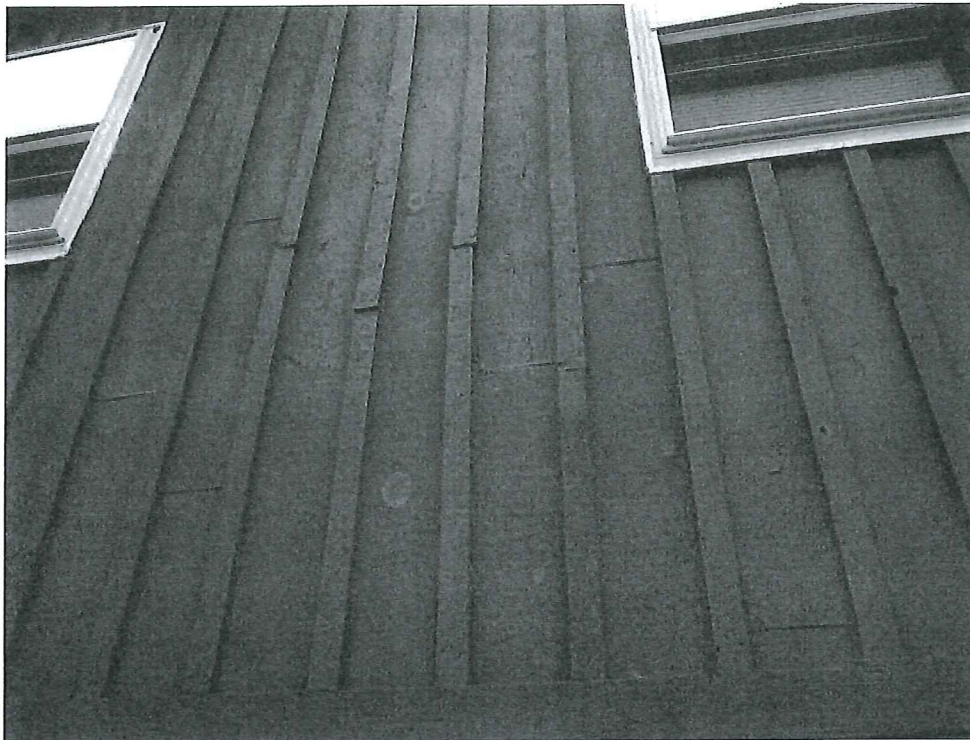
The existing siding on the Triplex buildings consists of vertical board and batten siding (see Photograph #7) with battens spaced at approximately 9" o.c. This siding is reportedly original to the buildings. This siding is in generally fair to poor condition, with significant deterioration at lower wall areas which are exposed to more moisture (see Photograph #8).

A significant concern with this type of siding is the fact that it does not shed water as effectively as other types of siding which are installed in overlapping fashion, such as clapboards or shingles. Water infiltration can occur through the joints between boards and battens and horizontal joints in taller wall sections.

Photograph #7 - Siding On Triplex Building

Replacement of the existing siding has been assumed in phases of two buildings per year, starting in ten years. It should be noted that there will significant costs associated with maintaining the existing siding, which will likely increase as these materials continue to age.

We would recommend that alternate siding materials which will be more weatherproof be considered, such as clapboards or shingles. Vinyl or other alternate

siding could be considered to reduce the maintenance requirements for the building. All new siding should be installed with a weatherproof building wrap and waterproof flashings at corners, penetrations and other critical areas. Given the age of these buildings, we would also anticipate significant sheathing and framing repairs will be necessary.

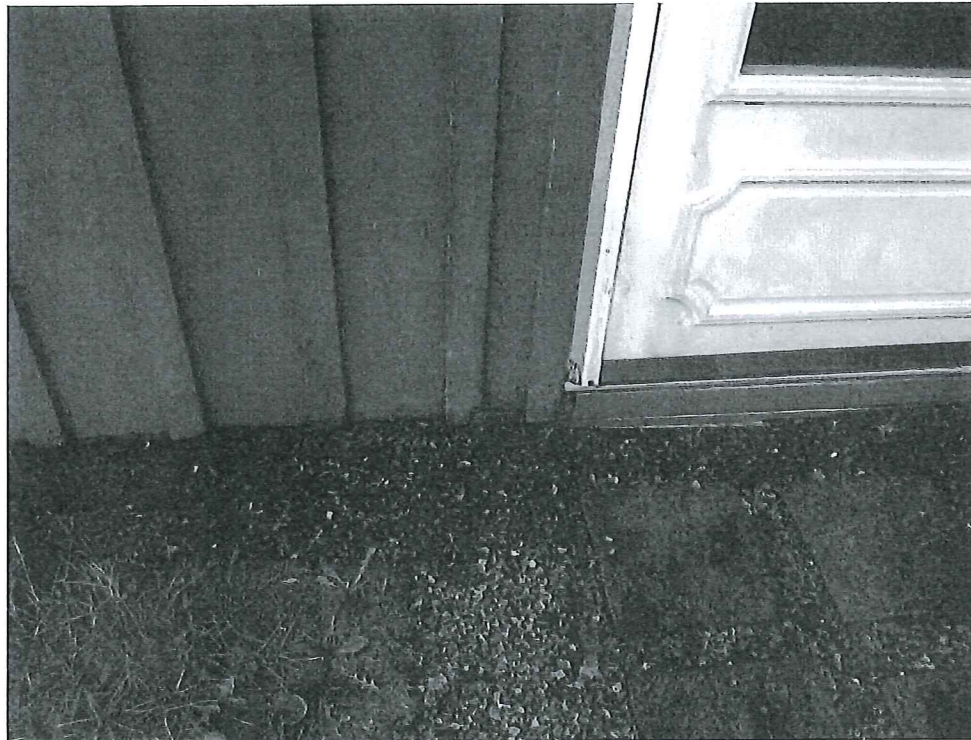
Photograph #8 - Deteriorated Siding On Triplex Building

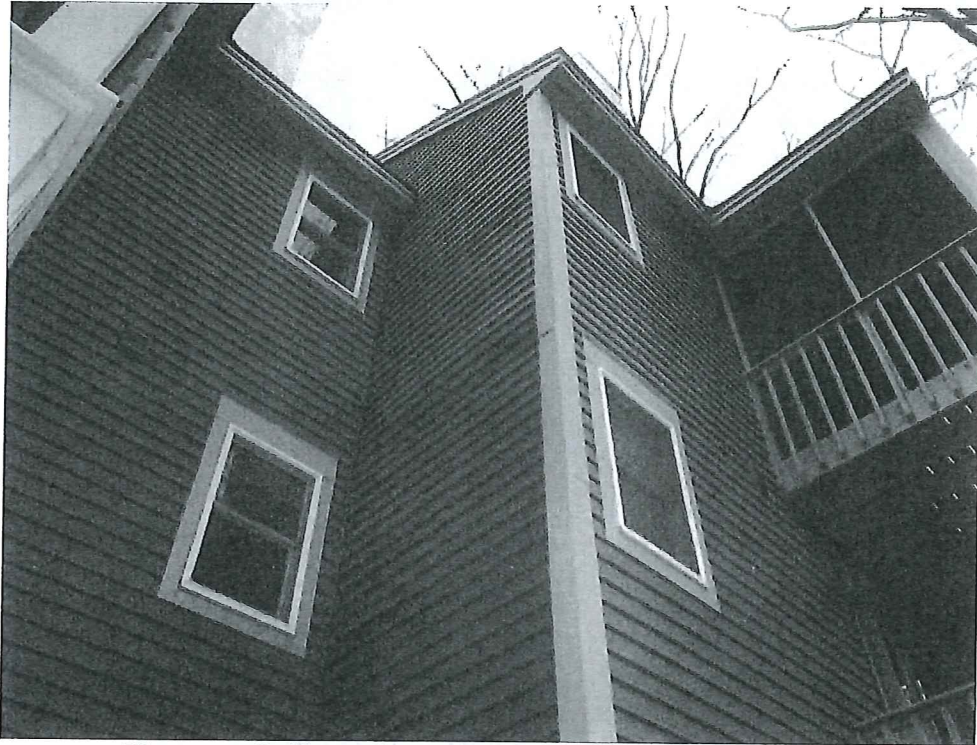
Photograph #9 - Bulging Siding On Rear Of Building #7

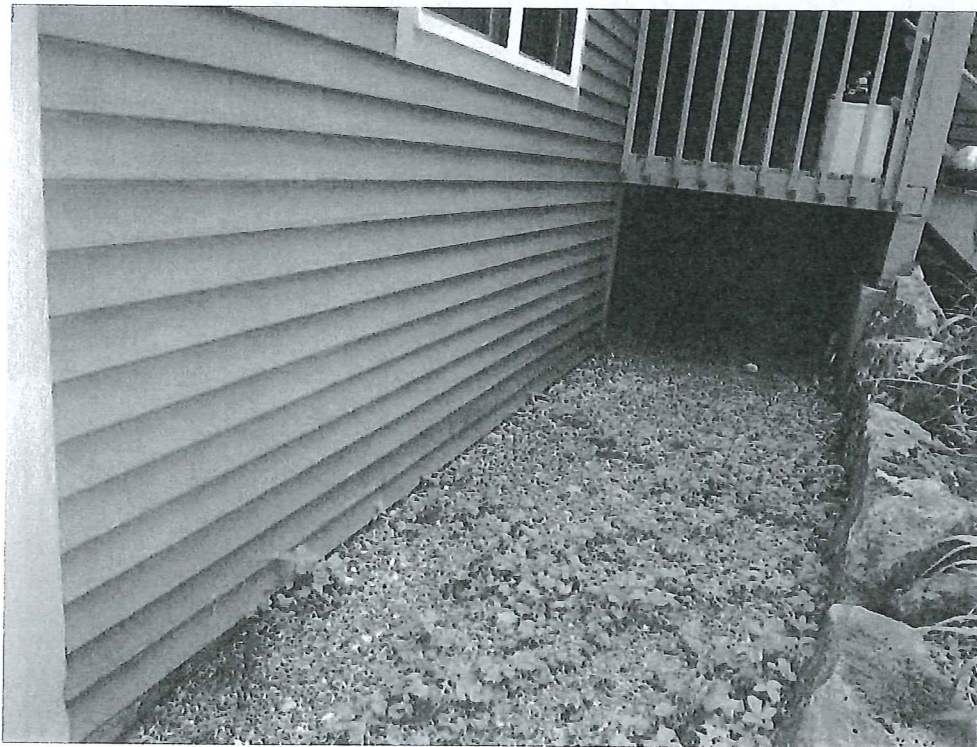
Grading - A number of areas were noted where the grade and landscaping materials are close to, or in contact with, the exterior wood siding and framing materials on these buildings (see Photograph #10). Contact between the wooden building structures and surrounding grade will promote deterioration of the wood due to the increased exposure to moisture from the surrounding grade materials. Prolonged periods of elevated moisture levels in wood promote the growth of wood destroying fungus and/or insects.

Contact between grade materials and wooden building components was noted on Units 7-1, 7-2, 11-2, 13-2, 15-1, 27-1 and 29-1. Contact or inadequate clearance was also noted on a number of the Triplex buildings, particularly along the sides of the building where the grade slopes.

Photograph #10 - Siding In Contact With Grade Materials

At the time of any siding replacement, areas with inadequate clearance to grade materials should be addressed by lowering the grade or building up the wall areas with decay resistant materials at the base of the walls.

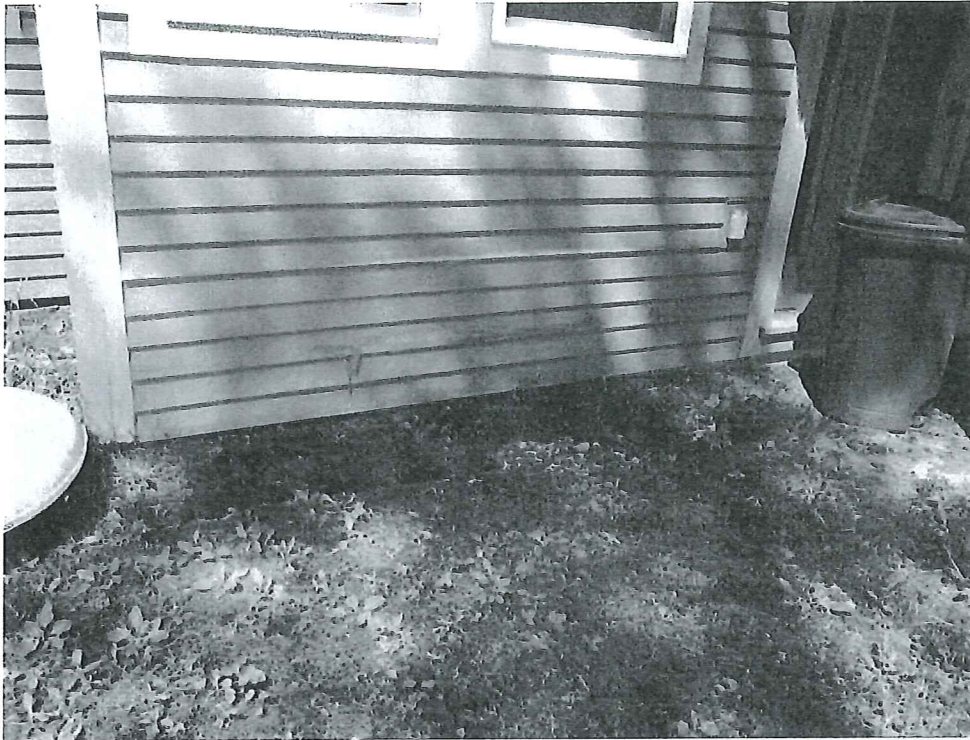
The existing siding on the Duplex buildings consists of beveled cedar clapboard siding with the rough side exposed and an exposure of approximately four inches. The clapboard siding appears to be medium grade material. Minor cracking of the clapboards was noted in several areas. Minor to moderate failure of the paint finish was noted, particularly on lower wall areas exposed to splash back from the roofs (see Photograph #11).

Photograph #11 - Failing Siding Finish

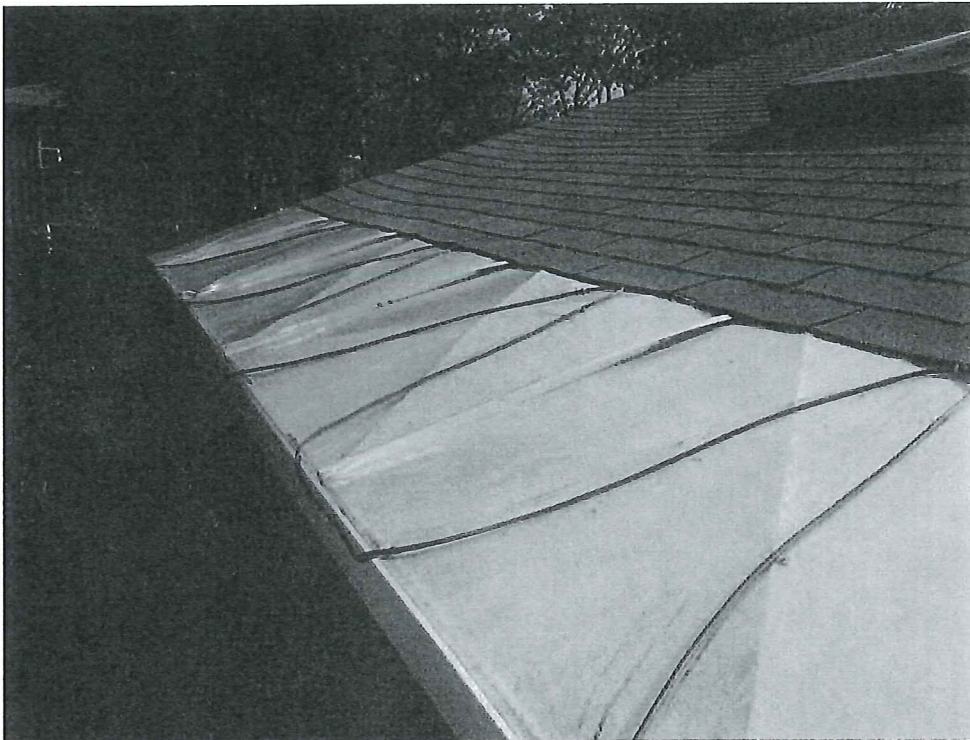
Photograph #12 - Metal Belt On Triplex Roof Eave

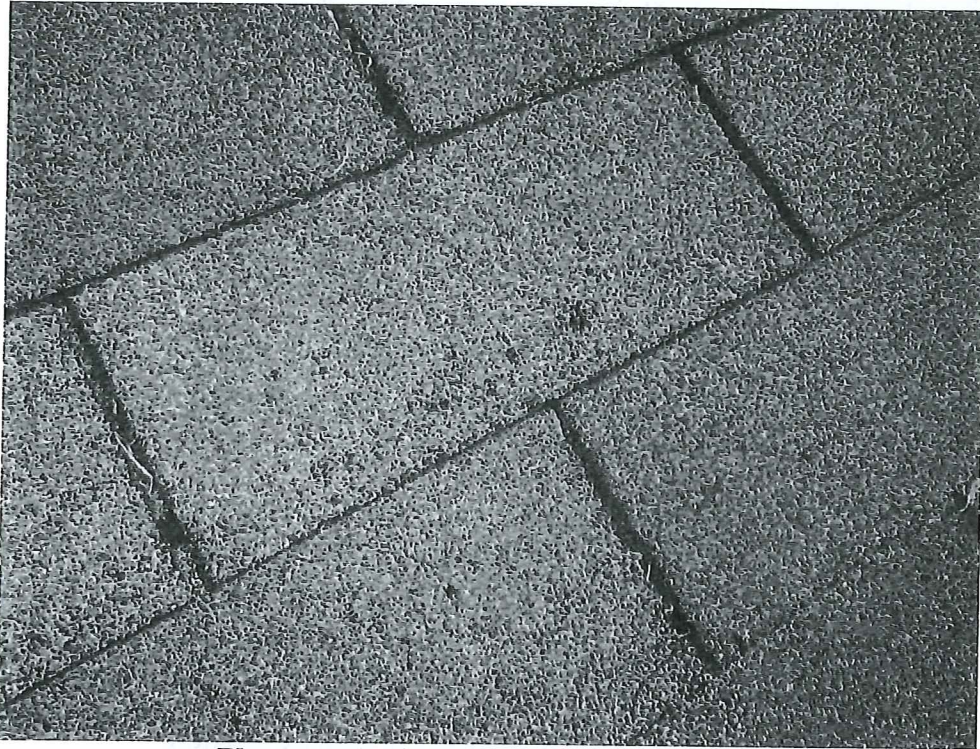
Inspection of these buildings showed the shingles to be in fair to poor condition in most areas. Shingle tabs are generally worn and torn in many areas. Also of note was blistering of the shingle tabs in many areas (see Photograph #13). This condition is caused when voids, or blisters, form in the asphalt shingles. These blisters can be caused by a number of factors, including moisture trapped between layers of shingles which is subsequently heated and expanded by the sun. This condition may be partially due to the relatively heavy tree cover around these buildings, which causes them to retain moisture when in the shade and then experience relatively quick temperature increases as the buildings come into direct sunlight as the day progresses.

Photograph #13 - Blistered Roof Shingles

Replacement of the existing roofs has been assumed in phases of two buildings per year, starting in one year.

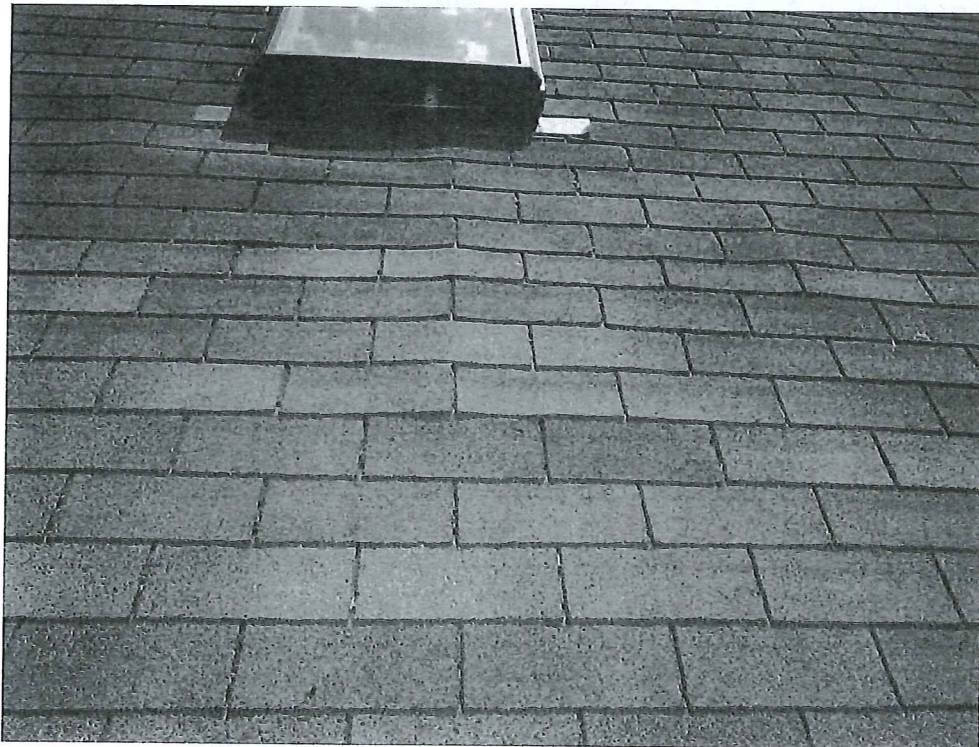
The plywood roof deck is noticeably deflected in many areas (see Photograph #14). In addition, the edges of the plywood roof deck appear to be loose and partially lifted in many areas.

Photograph #14 - Plywood Decking Lifting

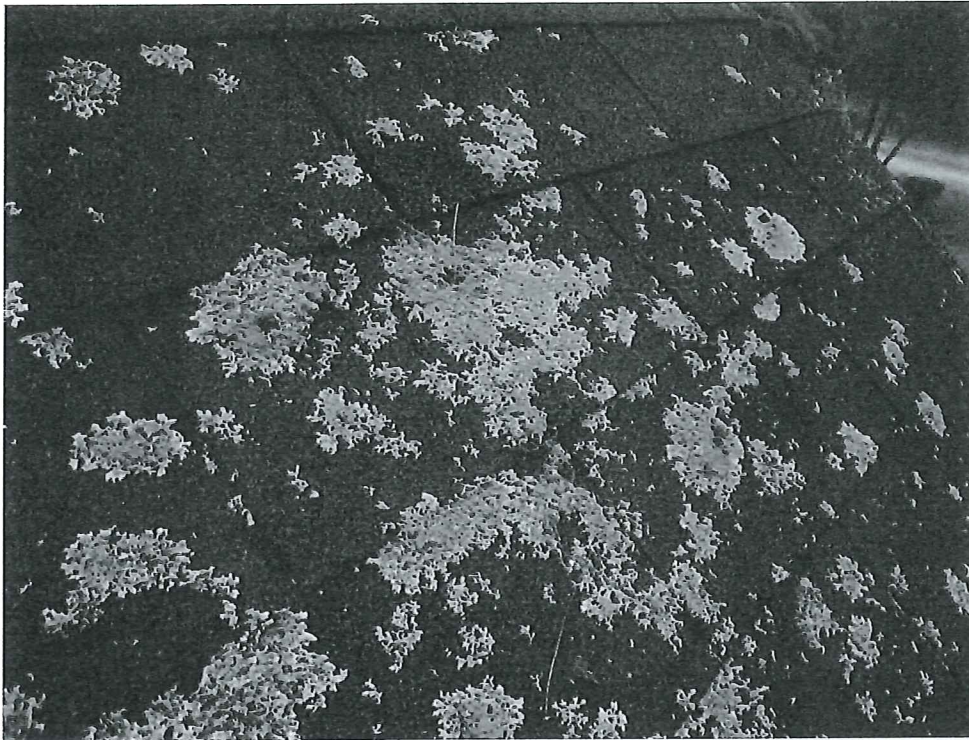
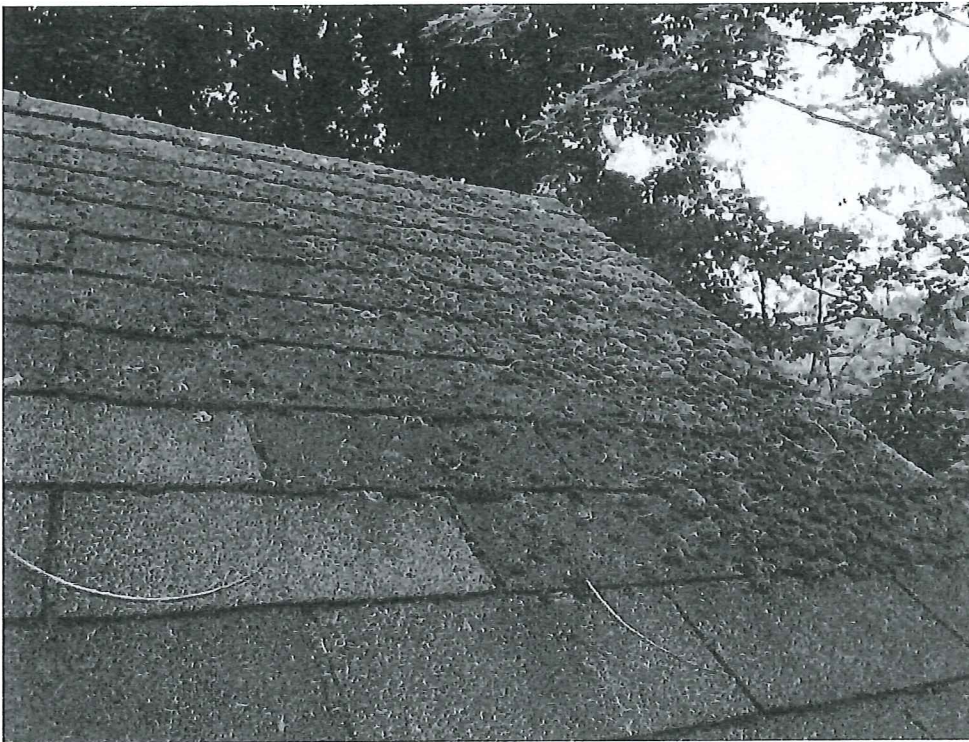
Significant lichen and moss growth was noted on shingle surfaces in many areas on these buildings (see Photographs #15 & #16). The growth of these plants will cause severe pitting of the shingle surface.

Photograph #15 - Lichen Growth On Duplex Building

Photograph #16 - Moss Growth On Duplex Building

Replacement of the existing roofs has been assumed in phases of two buildings per year, starting in one year. Reroofing with a moderate to heavy weight shingle has been assumed. Asphaltic waterproofing membrane underlayment should be installed in critical areas, including the areas above roof eaves, valley areas, dormers and gable walls. Reroofing is assumed to include removal of original shingles to allow for inspection of the plywood deck for possible deterioration or inadequate fastening.

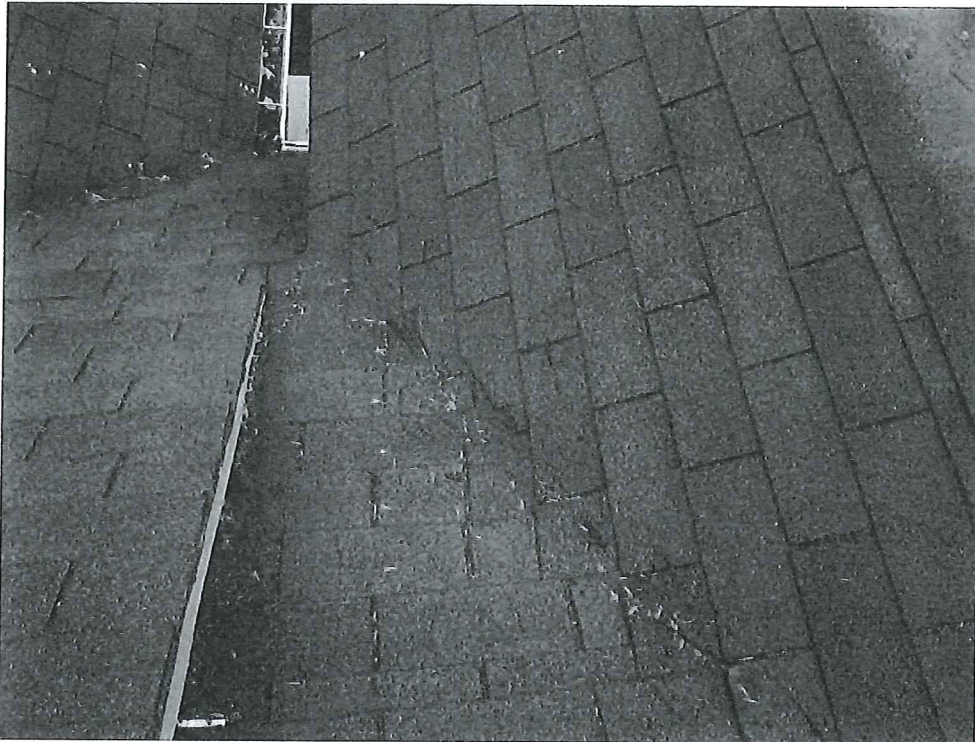
Photograph #17 - Damaged Roof Shingles On Duplex Building

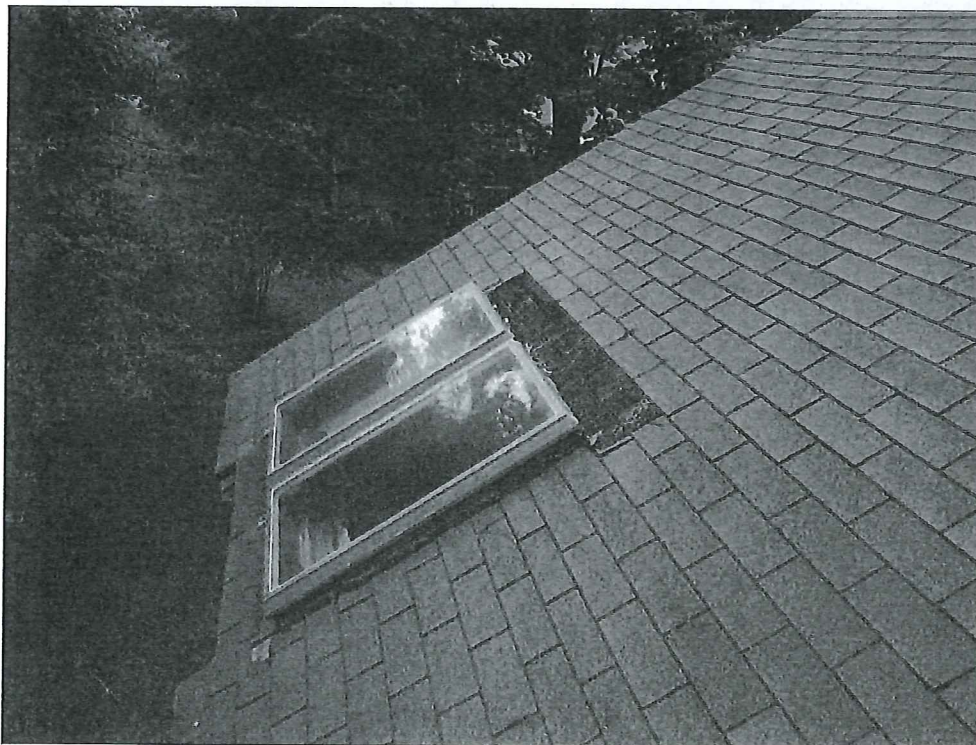
Various repairs were noted around the skylights, including shingle replacement, installation of exposed asphaltic membrane, and mastic repairs. It should be noted that asphaltic membrane is not intended for long term exposure to ultraviolet sunlight, and is an improper material for this application (see Photograph #18). The skylight on Unit 23 appeared to be new, and several other flashing repairs were noted on this building.

Photograph #18 - Exposed Waterproofing Membrane Above Duplex Skylight

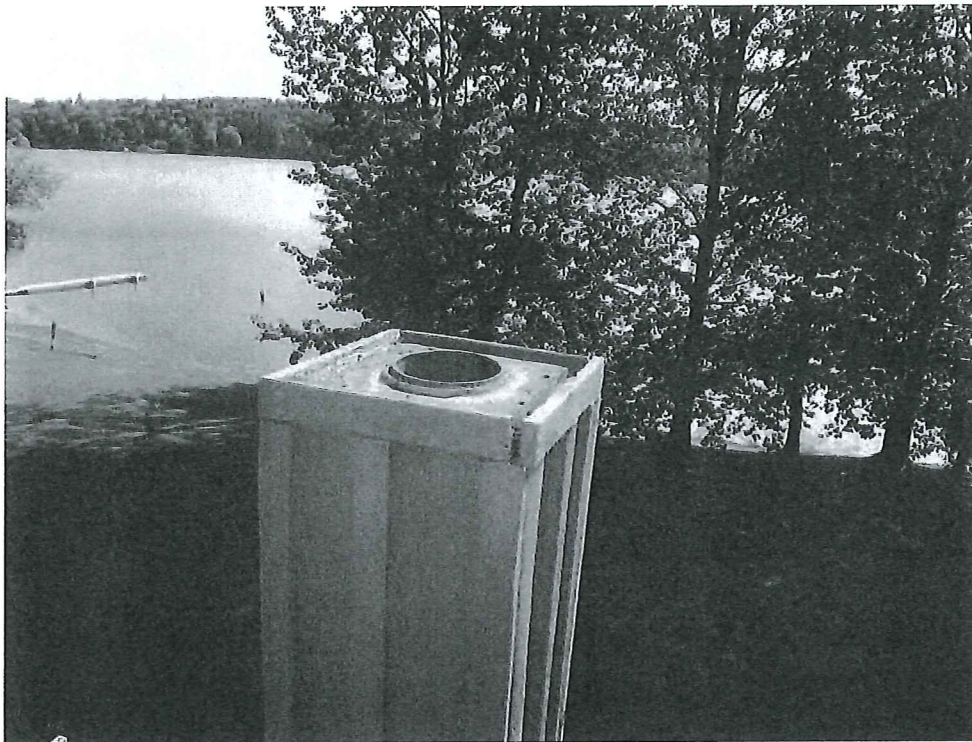
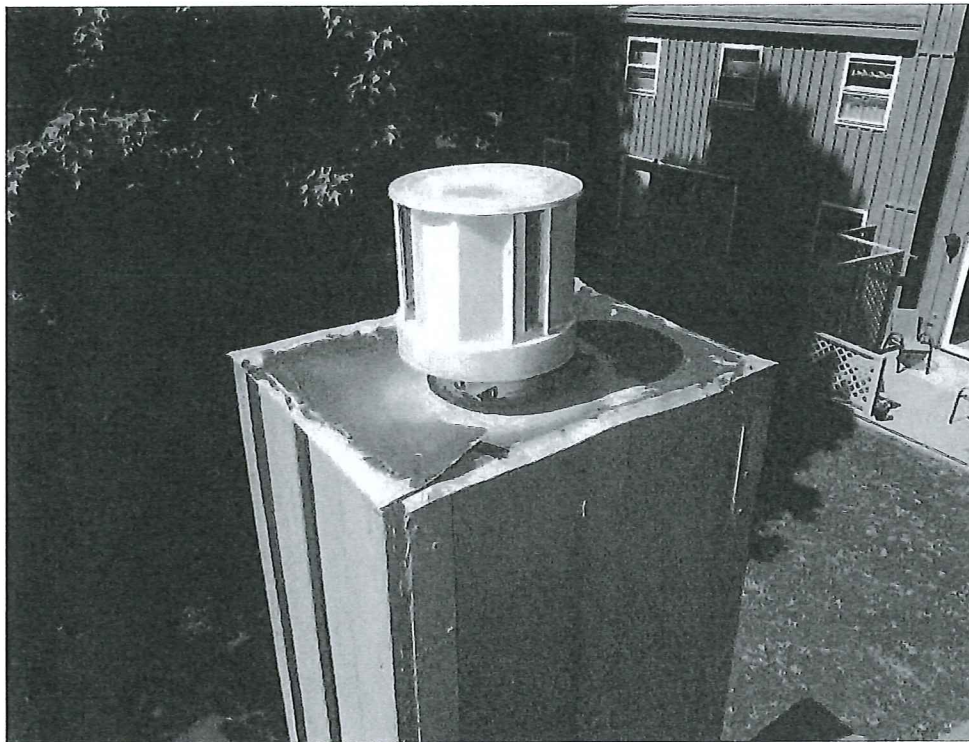
chimney structures covered with wood siding. Many of these chimneys have been capped with various metal caps or flashings, many of which do not appear to be watertight (see Photographs #19 & #20). In addition, some chimneys have been replaced with through-wall vents.

Photograph #19 - Triplex Chimney With No Cap Flashing

Photograph #20 - Triplex Chimney With Open Cap Flashing

As noted in Section 2.0, it is our interpretation of the Condominium By-Laws that chimneys are the Unit Owners' responsibility, and therefore are not included in our Reserve Funding calculations. However, we would strongly recommend that the Association establish guidelines for the regular inspection and maintenance of all fireplaces and chimneys, with inspections performed by a qualified professional. In addition, requirements for a complete, watertight cap flashing on chimney enclosures should be established to maintain the integrity of these structures.

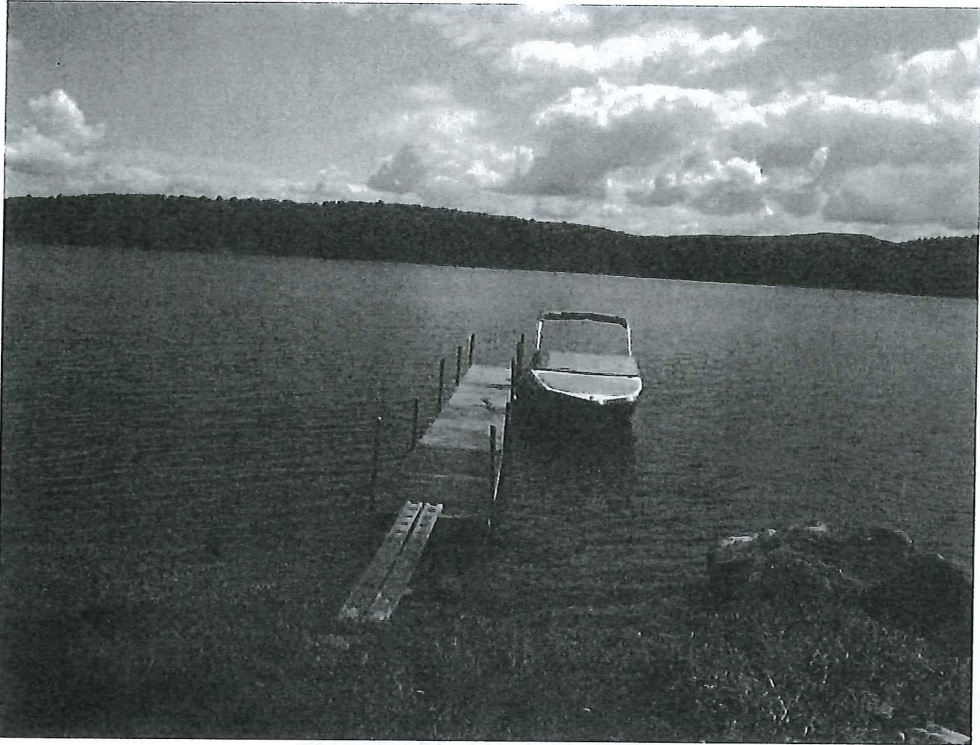
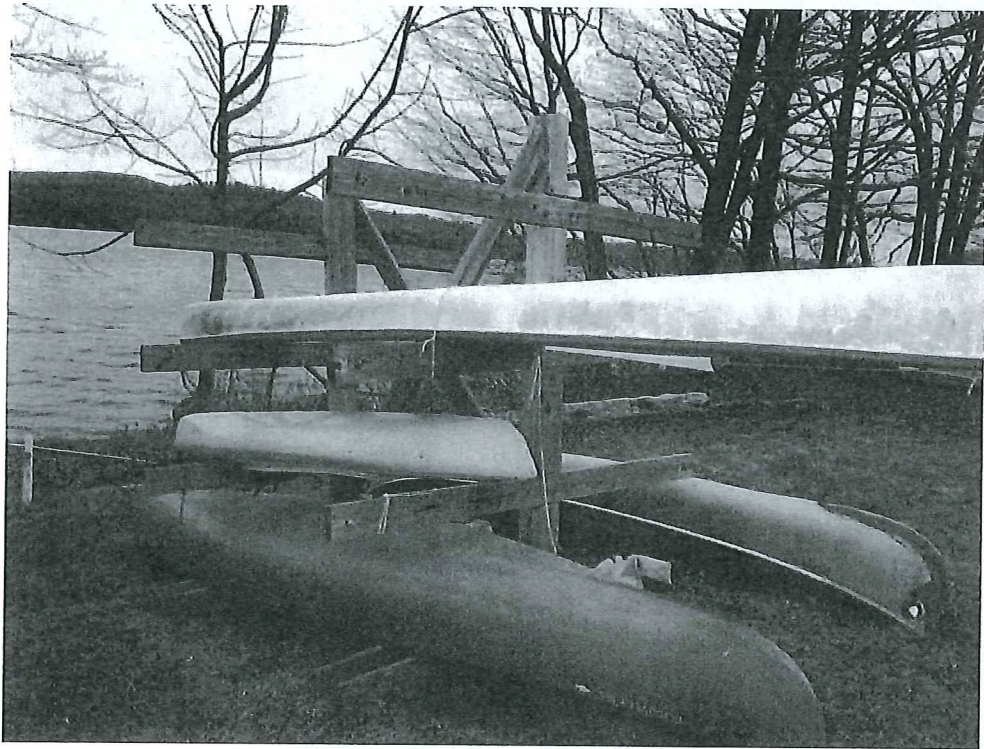
Beach Equipment - Replacement of the existing boat docks, swim dock and canoe racks has been assumed as noted in Appendix A (see Photographs #21 & #22). Replacement costs have been based on estimated time and materials to replace these items with comparable structures. Remaining service lives are based on the current conditions of these items.

Photograph #21 - Boat Dock

Photograph #22 - Canoe Rack

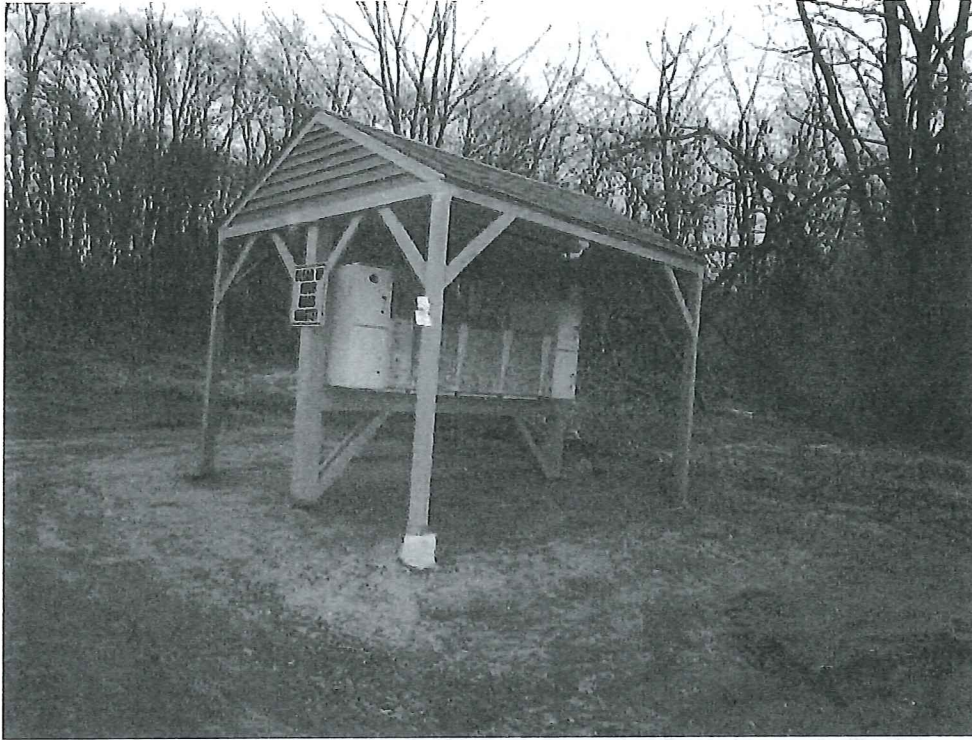
Mail Shed - The existing mail shed consists of an open air, wood framed structure housing individual standard sized mailboxes, and four oversized boxes for large items (see Photograph #23). The existing shed is in poor condition, at least partially due to apparent heaving of the corner posts. It has been noted that these posts will be fairly susceptible to heaving due to the fact that they are regularly cleared of snow which will maximize the penetration of frost into the ground.

Photograph #23 - Mail Shed

Replacement of the existing mail shed in the immediate future has been assumed as noted in Appendix A. Replacement costs have been based on estimated time and materials to replace the shed with a comparable structure. To help stabilize the new structure, it is assumed corner posts will be set on bell shaped footings set below the frost line.

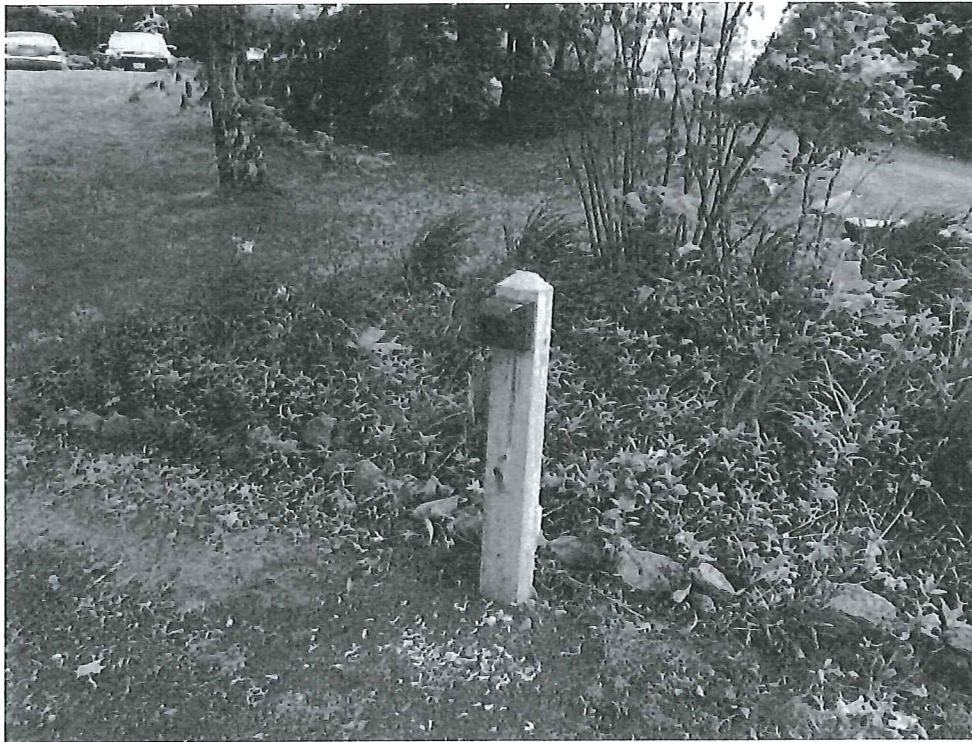
Walk Lights - Replacement of exterior walk/driveway lights has been assumed (see Photograph #24). This includes new fixtures and posts. Reuse of site wiring has been assumed. These lights are being replaced this year, so the funding shown in Appendix A would be for the next phase of replacement.

Photograph #24 - Walkway Light
